Madushan Dam – Repair

Yunnan Province, People's Republic of China
2010

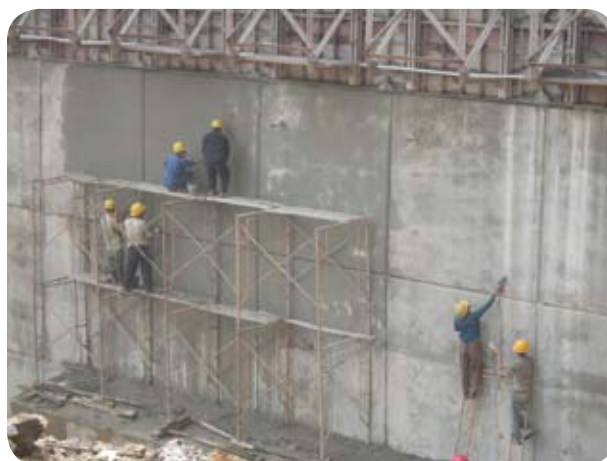
Crews applied T1 and T2 to the dam's walls to prevent water leakage and increase the durability of the structure.
