Royal Mills Riverpoint Apartments

West Warwick, United States (2010)

ROYAL MILLS RIVER POINT APARTMENT REHABILITATION

From Hydro-powered Cotton Mill to Dry Homes, with Kryton

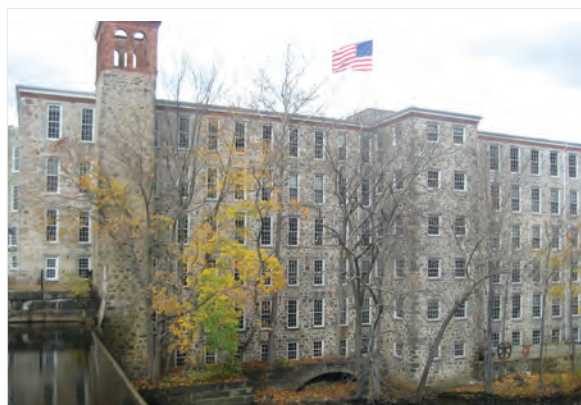
The riverfront location made external waterproofing challenging.

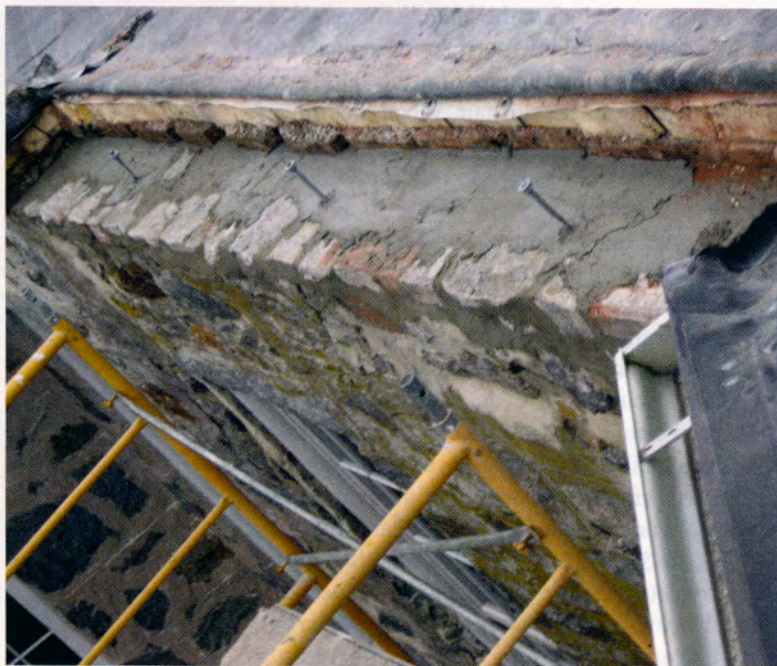
Royal Mills survived many years of harsh weather and industrial use

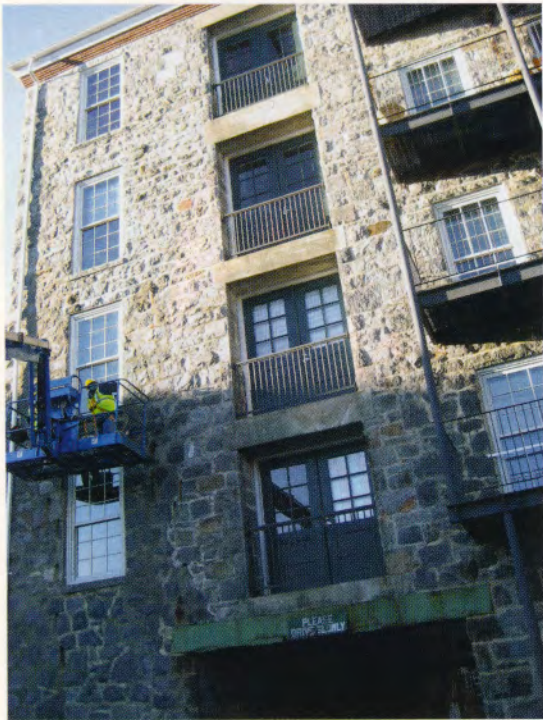
Nearly 2400 sills and lintels were repaired

- Several slabs poured using the same crystalline admixture to provide a permanent waterproofing solution and eliminate the need for an external membrane;
- Extensive windowsill and lintel repair with a variety of crystalline material;
- Several concrete and rubble elevator pit repairs; and
- Mold remediation to the areas that required it.

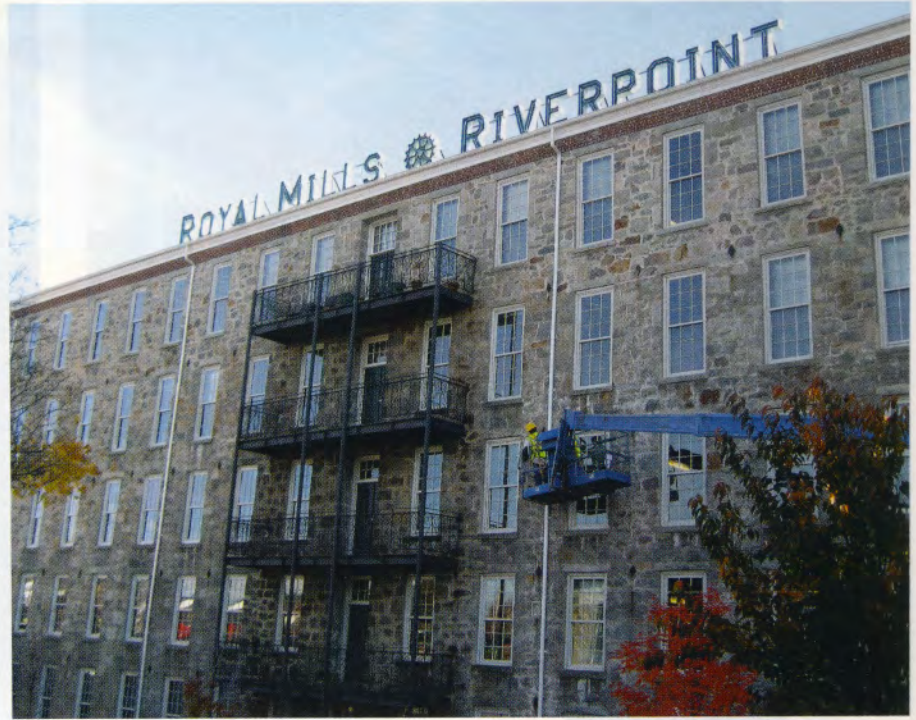
Extensive stone veneer repair work was completed

- 1000 linear ft (305 linear m) of sealed cracks;
- Cementitious concrete waterproofing slurry applied to interior walls to waterproof below the river level;
- 250,000 ft² (23,225 m²) of water-repellent sealer used to seal the original stone exterior and reduce water absorption;
- A crystalline admixture added to the mortar used to repair the historic stone veneer to reduce permeability;

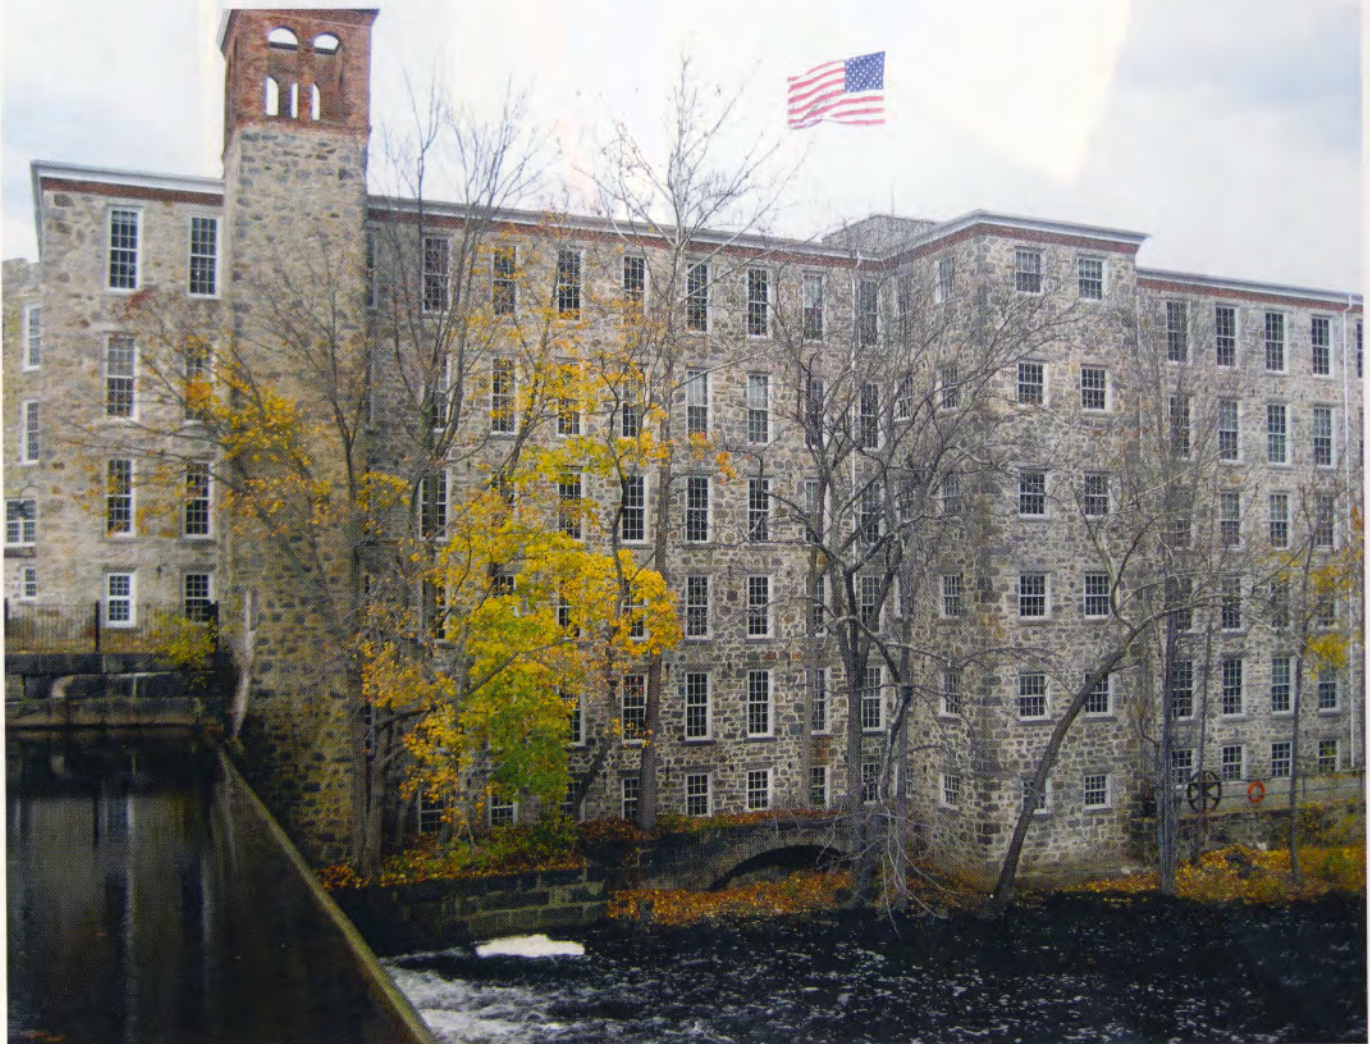
The riverfront location and waterfall posed a waterproofing challenge

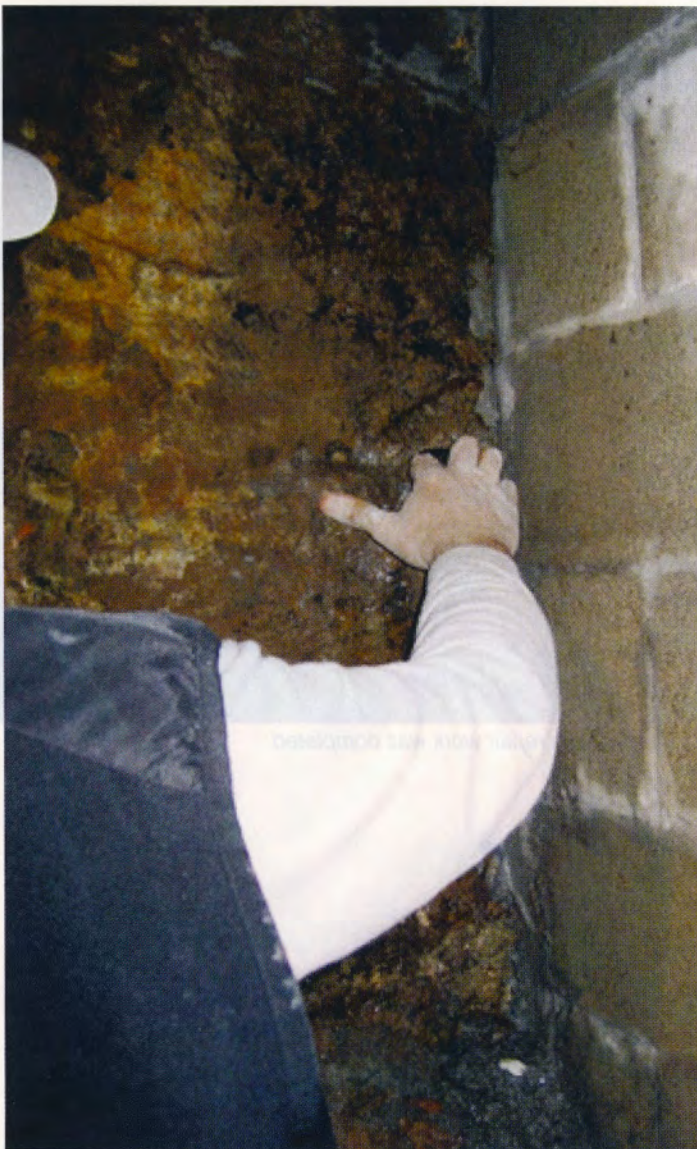
Crack repair was needed in elevator pits

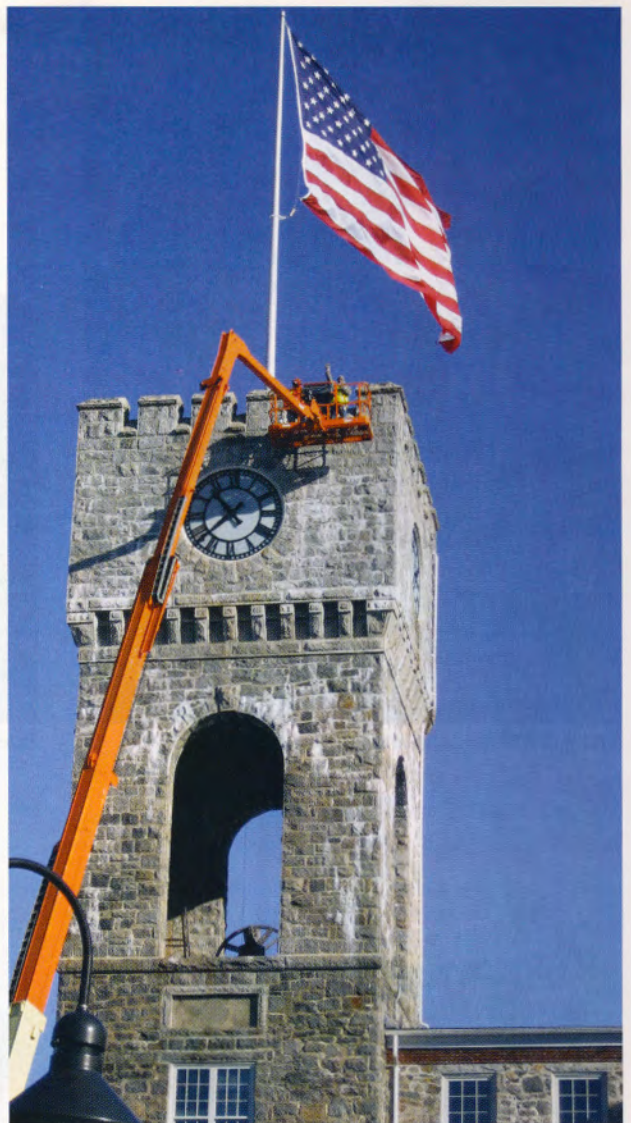
Extensive waterproofing and repair work was needed to revive the old mill

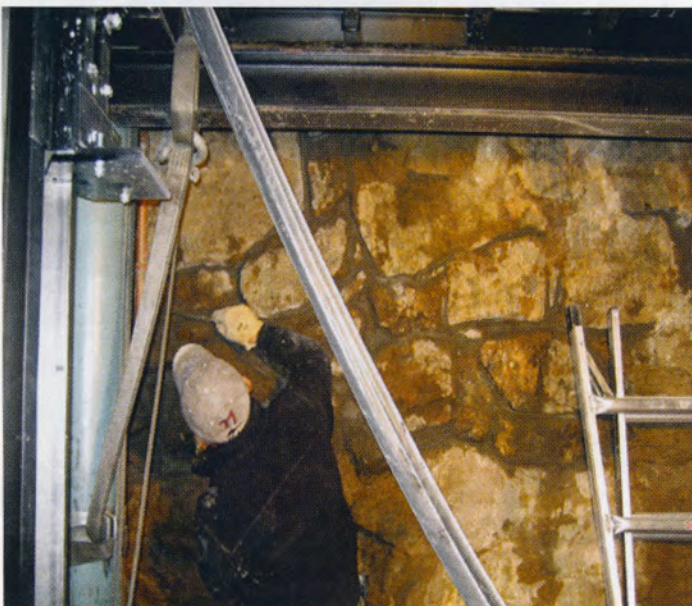
Extensive rubble elevator wall crack repair allowed the facility to pass inspection from authorities

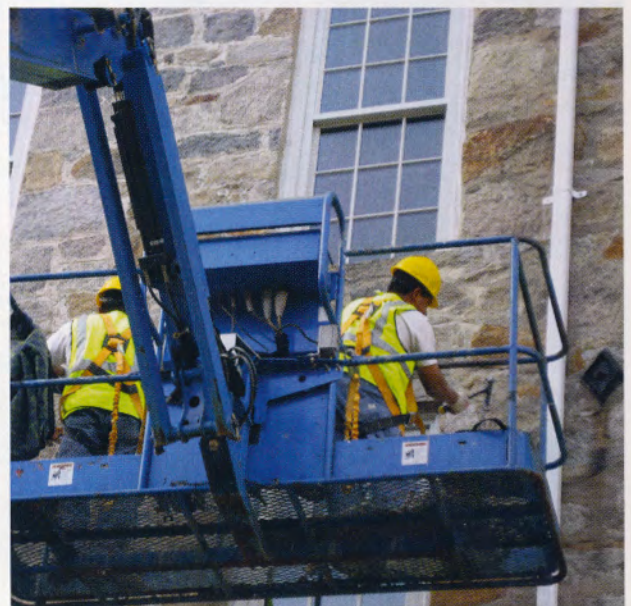
Historic reproduction of veneer stone—much with crystalline mortar

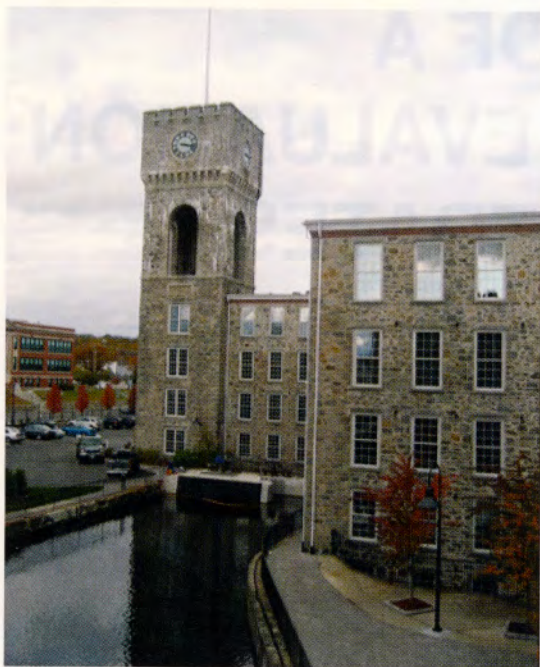
Canal dam head section received extensive reconstruction to stave off canal head pressure from lower apartment units
