University of Massachusetts Amherst - Boyden Tunnel

October 2008

BACKGROUND

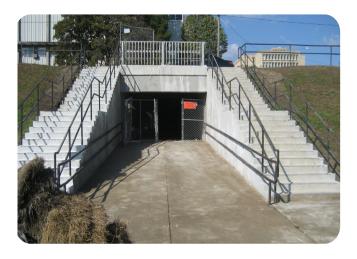
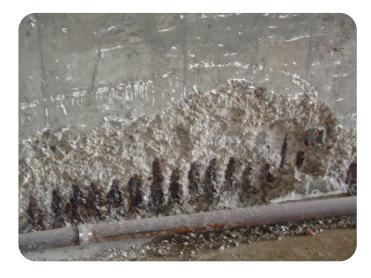
Deterioration and severe water intrusion within the tunnel forced the university to close it to pedestrian traffic.

The tunnel measures 165' long 10' high and 15' wide. Most of the water was entering through cracks and electrical/steam penetrations.

In total, there were close to 1000 linear feet of cracks and over three-quarters of that amount was located in the ceiling and wall spall.

After a week of preparation, Kryton's Crack Repair System was used on all of the leaking cracks and penetrations. KIM-dosed concrete was used for concrete beam repairs. Plasti-Patch was used extensively for general non-water related repairs. Depending on the water challenge, the many splintered areas were repaired with Baricoat in 1/4" lifts.

The entire tunnel and outside adjacent stairways was then coated in T1 and T2 surface-applied treatment and the floor sprayed twice with Hydrostop.
